# Water plus Advanced Services Report

**2001890-Stapeley Community Hall**

**Leak Detection Report**

**16<sup>th</sup> August 2019**

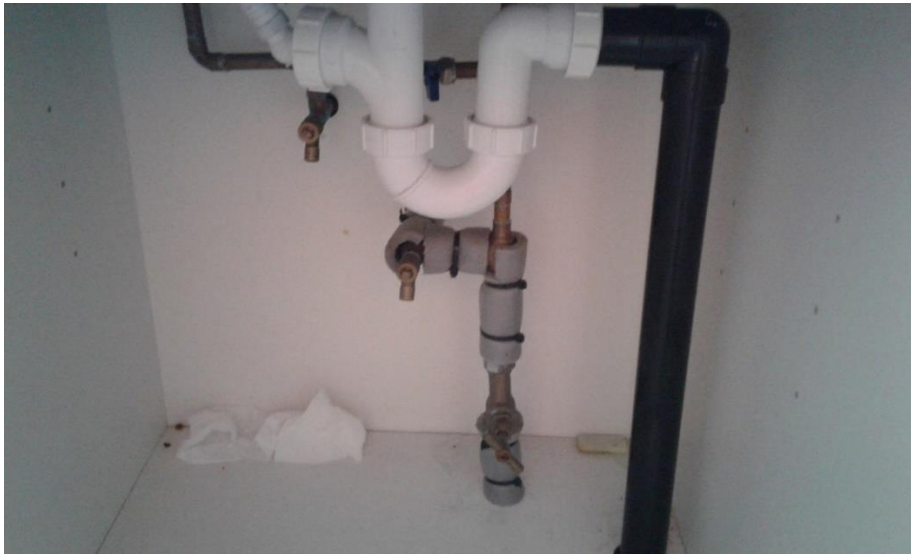
Firstly I checked the water meter, which was recording a flow of water. I went inside the building to locate the internal stop tap, this was found in the kitchen area under the sink unit. I isolated the tap and checked the water meter again, this had stopped recording proving there was no leak on the pipework from the water meter to the internal tap.

Internal Stop-Tap under kitchen unit

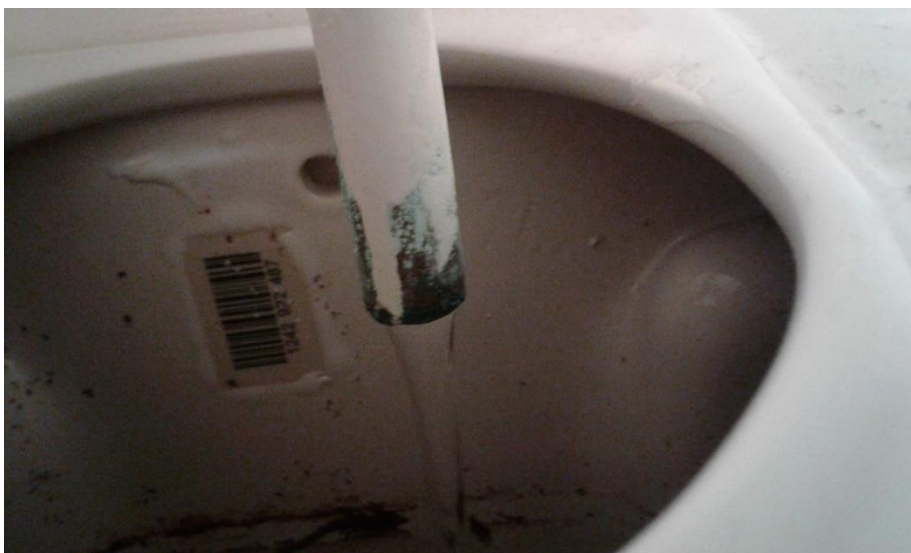
I then checked around the building for any misuse (toilets, taps), when I checked the male toilets the urinals were running constantly so this was the problem.

Urinals constantly flowing.

After reviewing the report we would recommend the replacement of the Flow Control in the males toilet.

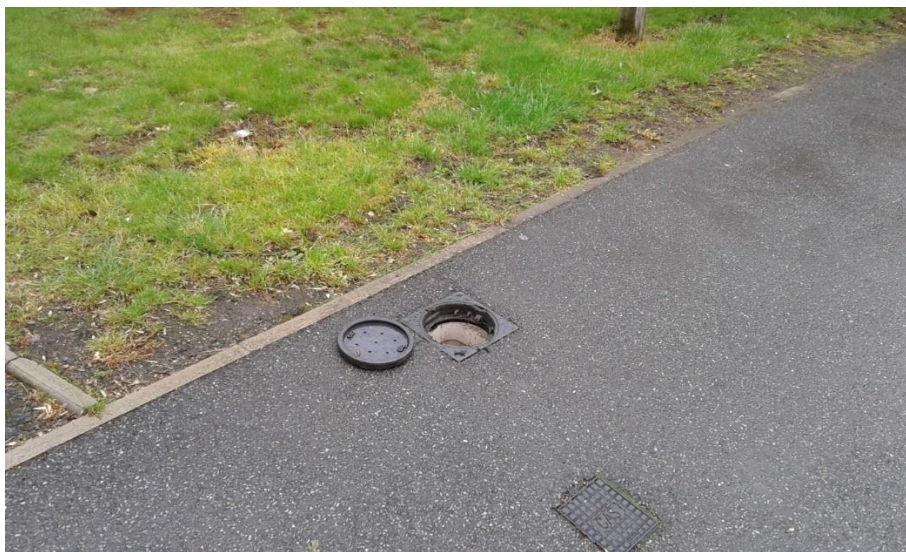
Meter in tarmac footpath by main gate

We would also suggest taking regular meter readings regularly.

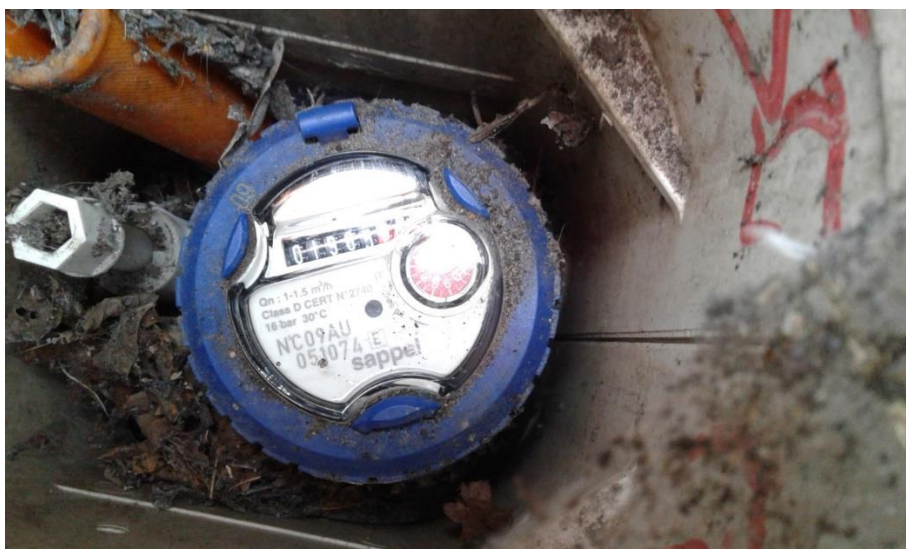
Meter in chamber

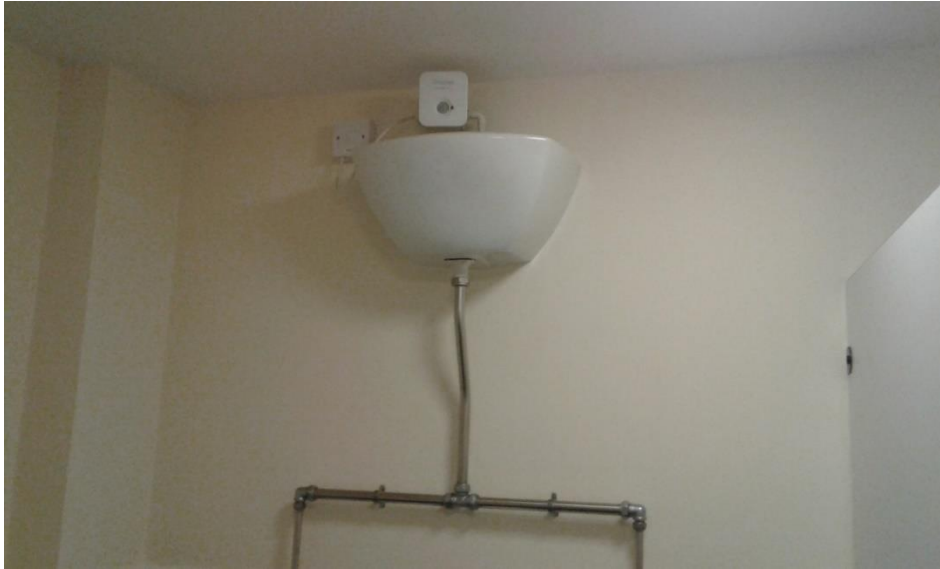
Flow Control to be replaced
