Vehicle-activated signs – a large scale evaluation

Prepared for Road Safety Division, Department for Transport

M A Winnett and A H Wheeler

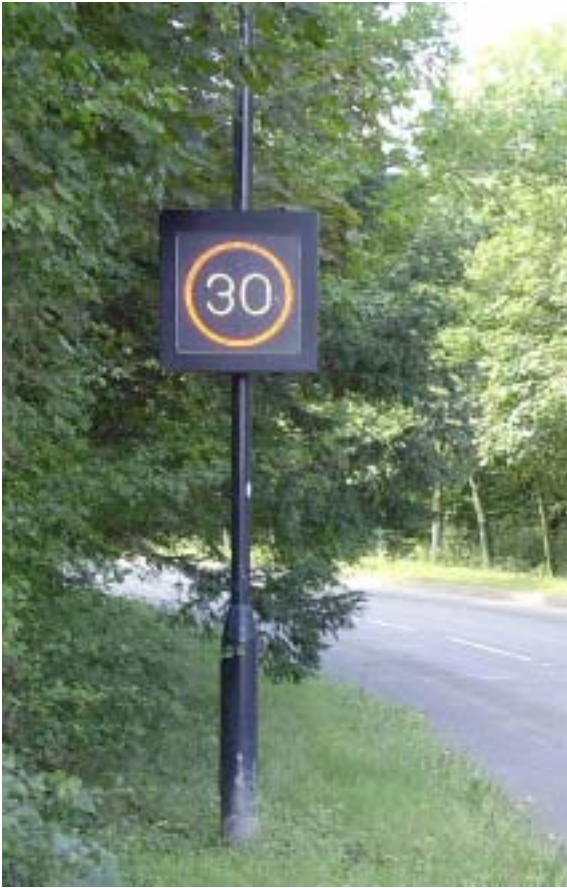
Plate 5 30 roundel without flashers (Brisley, Norfolk)

Vehicle-activated speed roundel signs are not repeater signs since they will only operate for drivers exceeding the speed limit. Consequently they do not display to all traffic. Their purpose is to reinforce the posted speed limit. Speed limit roundels were installed between 20 metres and 50 metres beyond the first sign indicating the change in the speed limit. For example, on a section with a 30mph limit, the vehicle-activated sign would be situated within this speed limit, 20-50 metres downstream from the speed limit terminal sign.

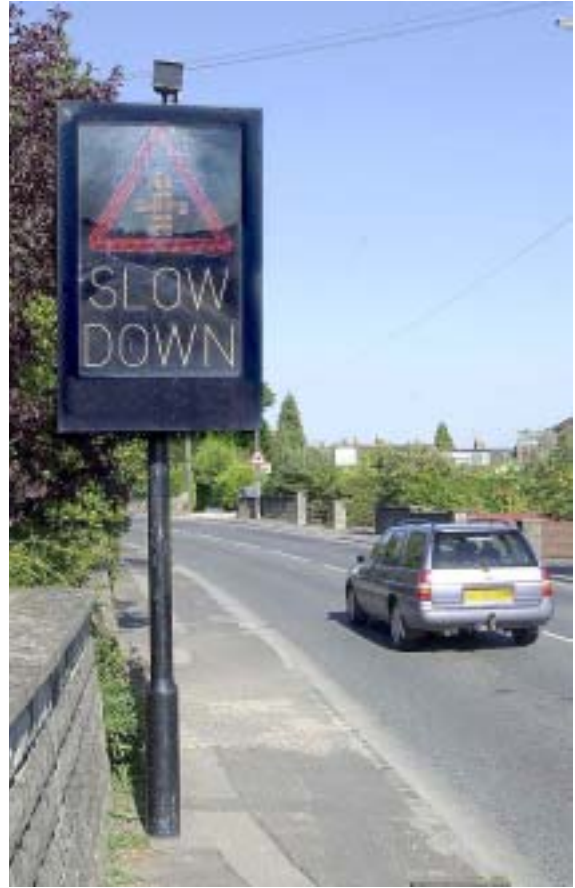
Plate 7 Junction warning sign (Wootton Bassett, Wiltshire)

It is not always possible to reduce speed limits over a short distance where there is a hazard related to speed and this highlights the fact that speed limits are often inflexible. The junction warning signs are designed to deal with this particular problem. These signs have been located between 100 metres and 150 metres from the centre of the junction.

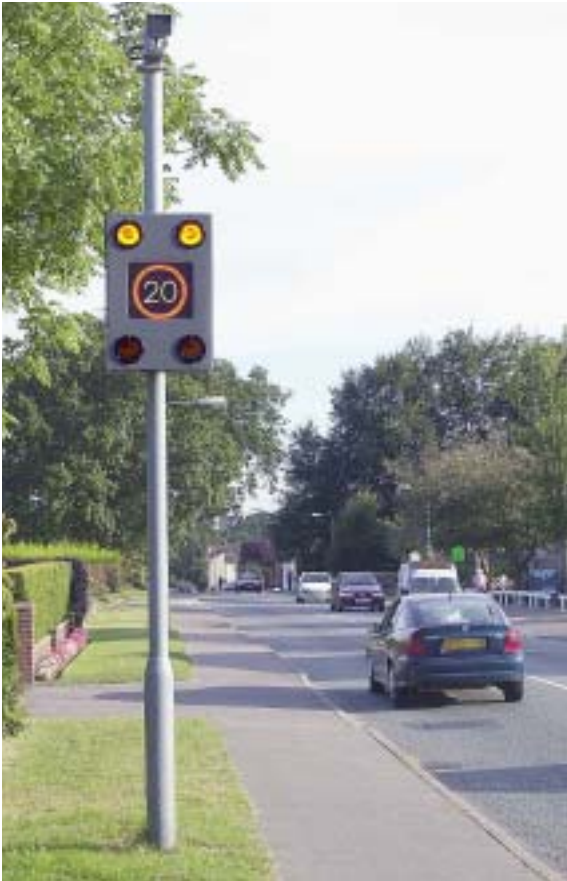
Plate 6 20 roundel with amber flashers (Horsford, Norfolk)

The signs in Kent and some in Norfolk were complemented by pairs of flashing amber lights that are triggered at the same time as the sign itself.

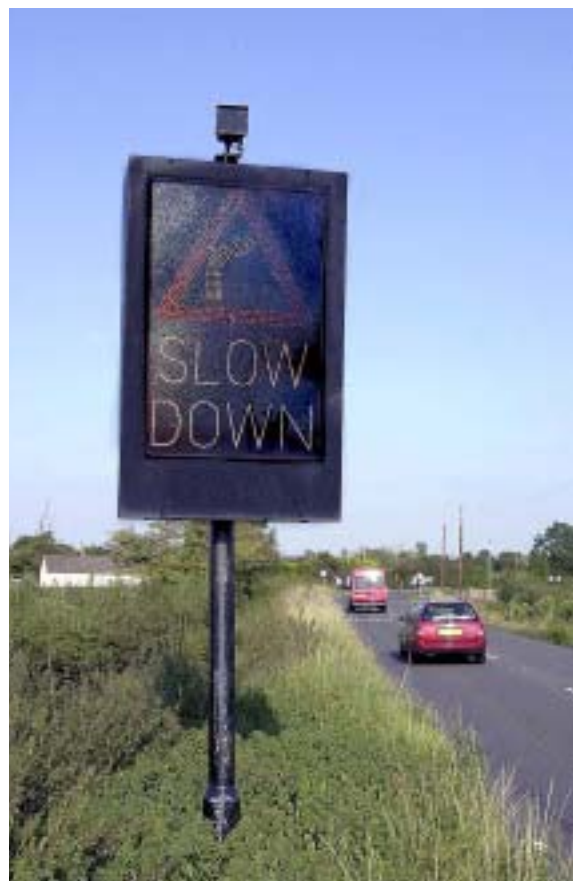
Plate 8 Bend warning sign (Sells Green, Wiltshire)

A major contributory factor reported by the police in bend accidents is excessive speed for the conditions. The bend signs were developed to deal with the problem of accidents involving loss of control due to excessive speed on the approach to bends. Many of these accidents are also associated with wet roads where tyre adhesion is reduced. This highlights the problem that drivers do not always take into account the prevailing conditions and adapt their behaviour accordingly. It is possible that since many of these accidents occur on minor roads, with a high proportion of local traffic, over-familiarity with the route and lack of concentration may be additional contributory factors. The signs give advance warning of the hazard, to reinforce the potential risk associated with the bend. These signs were located between 50 and 100 metres in advance of the apex of the bend.
