# Water plus Advanced Services Report

**2001890-Stapeley Community Hall**

**Leak Detection Report**

**16<sup>th</sup> August 2019**

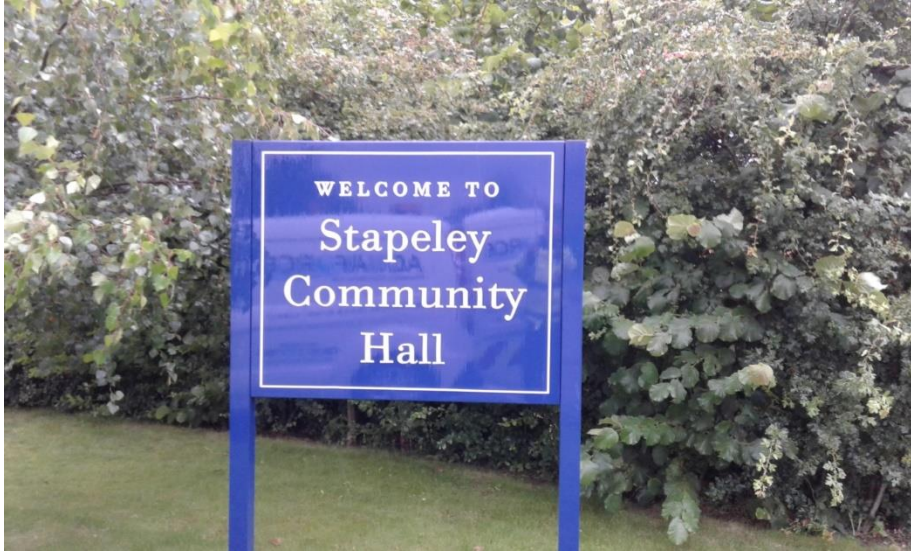
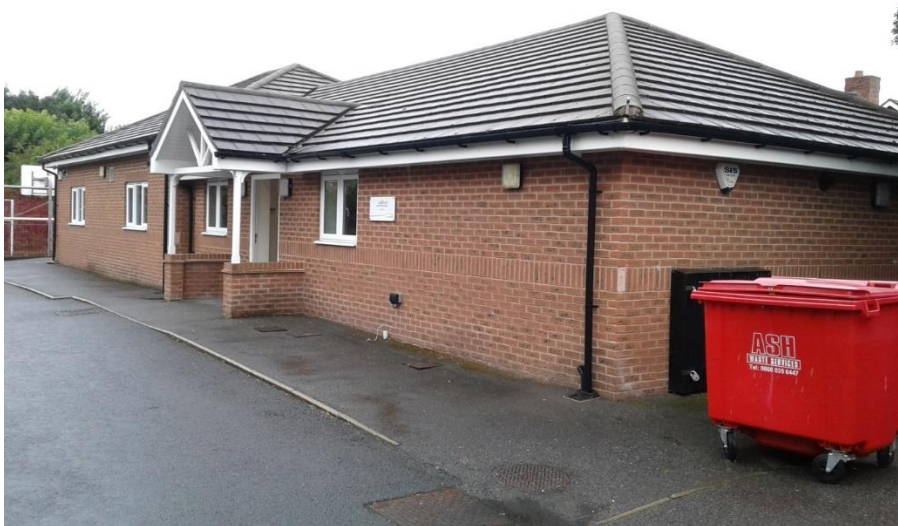
Firstly I checked the water meter, which was recording a flow of water. I went inside the building to locate the internal stop tap, this was found in the kitchen area under the sink unit. I isolated the tap and checked the water meter again, this had stopped recording proving there was no leak on the pipework from the water meter to the internal tap.

I then checked around the building for any misuse (toilets, taps), when I checked the male toilets the urinals were running constantly so this was the problem.

After reviewing the report we would recommend the replacement of the Flow Control in the males toilet.
